# Manhole Inspection Summary

Manhole # S41A2\_017MH

Insp Date: **12/6/07 8:40 AM**

**Location** Address: **3606 9th St**

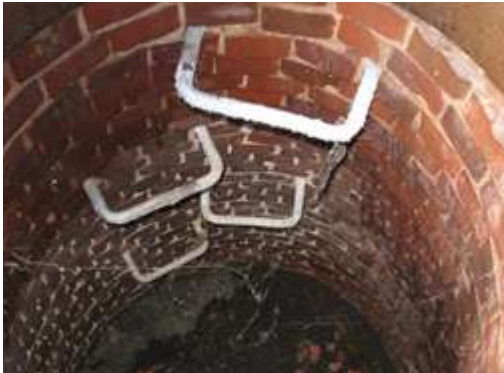
Steps

**Steps** Count: **4** Missing: **0** ☐ Corroded

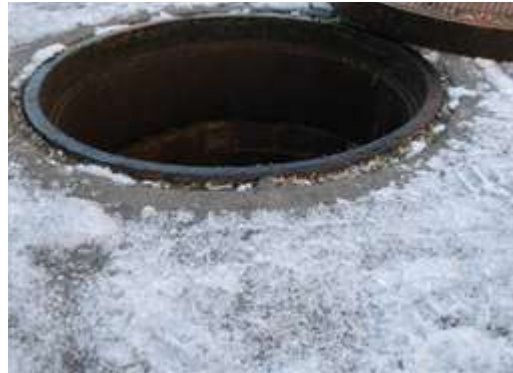
Defect 2

**Cover** Shape: **Circular** Diameter: **24** (in.) Length: (in.) Dist A/B Grade: **0.5** (in.)

Above grade

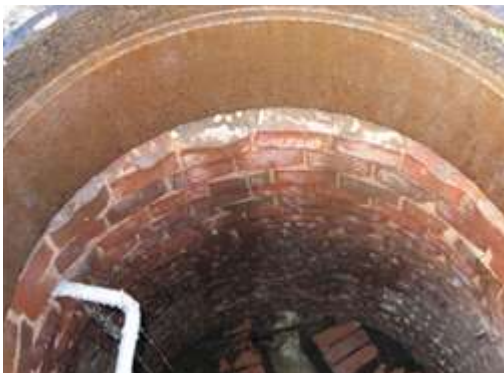
Defect 1

**Frame** Offset: **1** (in.) Condition: ☒ Sound ☐ Cracked ☐ Leaks

Frame offset

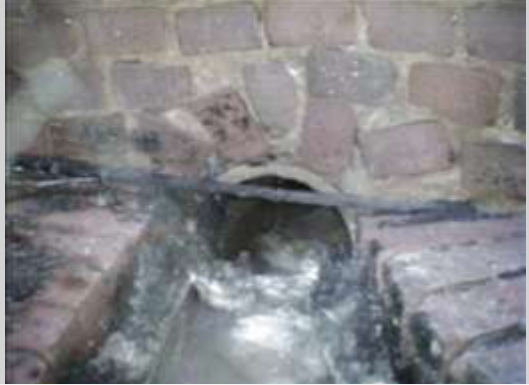
12 O'Clock Outflow

8 in. Circular Gravity Sewer  
Pipe Out @ 12 O'Clock

Pipe Height: **9.6** (in.) Rod and Bar (Angled)  
Pipe Material: **Clay** ☐ Pipe Lined  
Invert Depth: **7.80** (ft.) Flow Characteristics: **Fast**  
Deposits: ☐ None ☐ Mud ☐ Sludge ☒ **Debris** ☐ Grease  
Silt Depth: **2** (in.) Deposits Extent: **Light**  
Infiltration: **None** Pipe Seal Cond: **Sound**

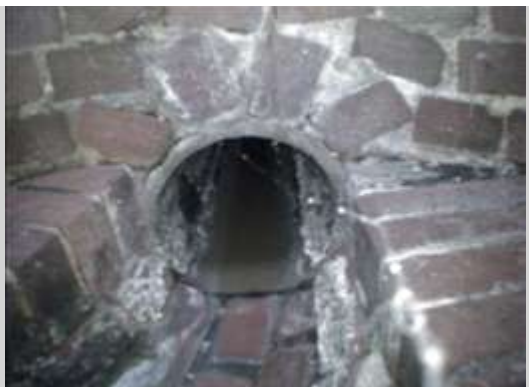
3 O'Clock Inflow

8 in. Circular Gravity Sewer  
Pipe In @ 3 O'Clock

Pipe Height: **9.6** (in.) Rod and Bar (Angled)  
Pipe Material: **Clay** ☐ Pipe Lined  
Invert Depth: **7.57** (ft.) Flow Characteristics: **Fast**  
Deposits: ☒ **None** ☐ Mud ☐ Sludge ☐ Debris ☐ Grease  
Silt Depth: (in.) Deposits Extent:  
Infiltration: **None** Pipe Seal Cond: **Sound**
